Re: Request for Sanctioning of Lubrication Tests

PROPOSAL OF TESTING OF MULTI—PURPOSE LUBRICANT
CAMTRON 4039 SPECIAL APPLICATION SYNTHETIC OIL
7 SEPTEMBER 1983

CamTron II, Inc. worked in concert with Jonco Industries, Inc. to produce a lubricant which would solve the lubrication problems of the M-113 angle drive cooling fan. The lubricant which was produced thru that research and development was designated CamTron 4039 and was tested at Fort Hood during May and June 1983.

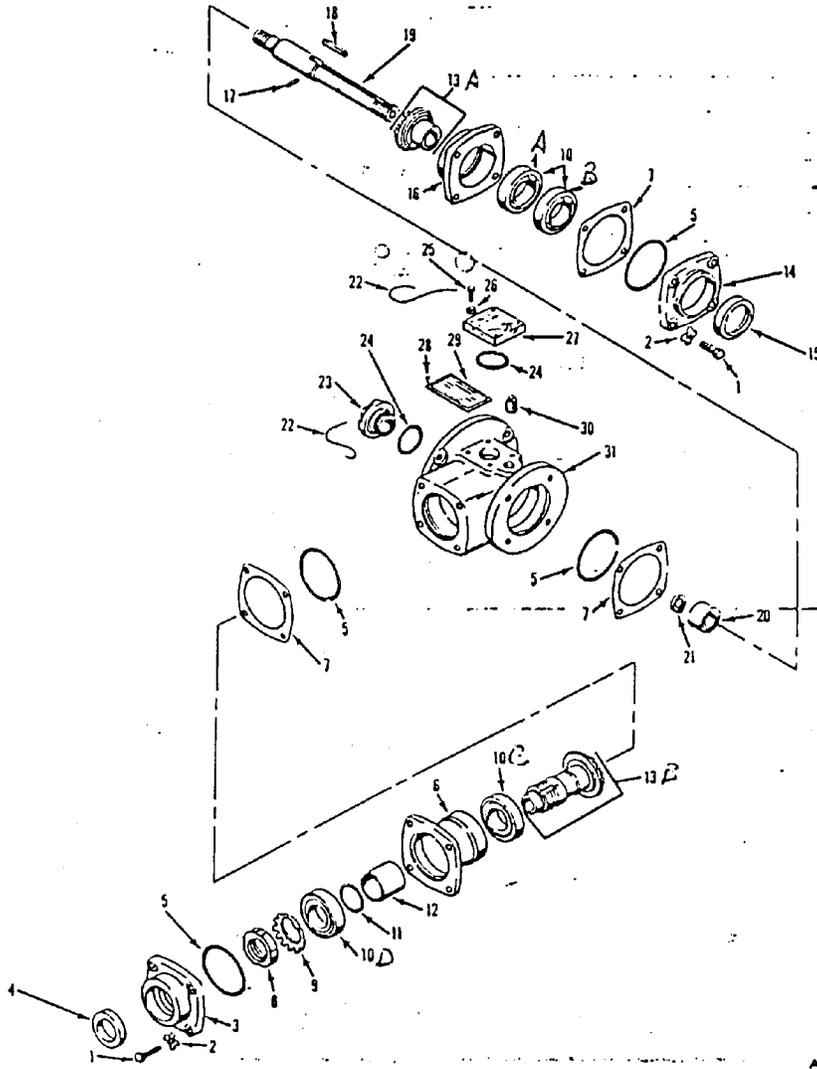
Figure 1. Cooling fan angle drive assembly.

The failures most frequently occur in the bearings captioned as 10A—10B—10C—10D in the exploded diagram (appendix II). Deterioration of gears 13A and 13B occurs in concert with the bearing failure. When these failures occur, the results can range from cessation of movement of the impeller to total disintegration of the gear assembly.
