### **Testimonial: Very Hard To Start**

My Yamaha XT600 2003 model air cooled, single cylinder, 4 valve, 4-stroke, road-trail motorcycle with an electric start was bought second hand (4,000 km) in 2007.

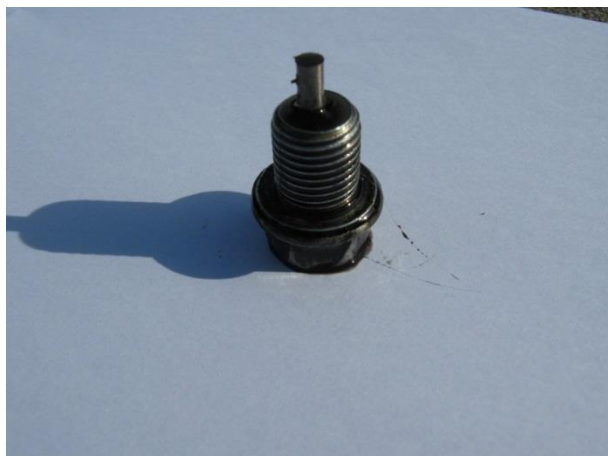
Figure 2 XT600 ~80,000 km magnetic sump plug during oil change showing almost no ferrous metal

The wear on an air-cooled motorcycle can be truly frightening. By using a magnetic sump plug it was possible to see a large halo of ferrous metal attached to the magnet when the oil was changed. After treating with Xcelplus the metal on the sump plug was reduced by >50 %.

Using a high-quality oil with Xcelplus reduced wear more than using a poor-quality oil. The difference was obvious when the oil was changed: The amount of ferrous metal on the magnetic sump plug varied according to which oil was used. A high quality semi-synthetic 20-50 W provided good lubrication at a reasonable price point.
